## **JT9D Ceramic Outer Air Seal System Refinement Program**

UNITED TECHNOLOGIES CORPORATION  
PRATT & WHITNEY AIRCRAFT GROUP  
COMMERCIAL PRODUCTS DIVISION

1. Report No. <b>NASA-CR-165554</b>		2. Government Accession No.		3. Recipient's Catalog No.	
4. Title and Subtitle <b>JT9D Ceramic Outer Air Seal System Refinement Program</b>				5. Report Date <b>January 27, 1982</b>

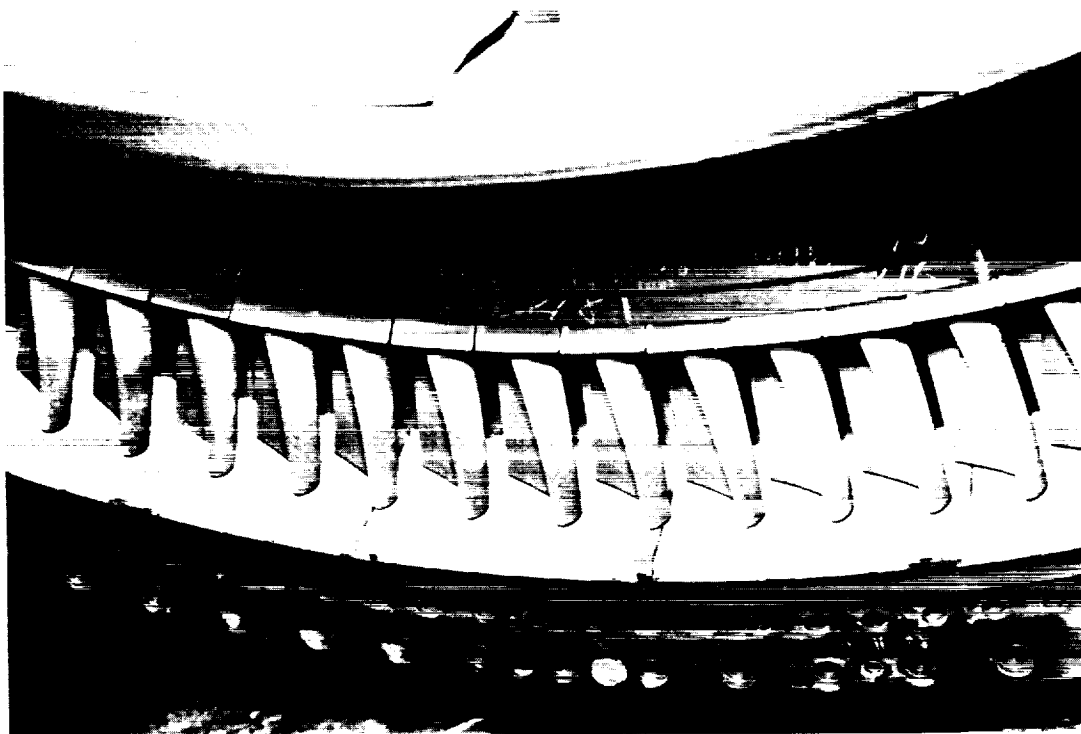
Figure 33 Most Seal Segments were Unaffected by Exposure to 2500 Engine Cycles
